REPORT OF GEOTECHNICAL ENGINEERING SERVICES FOR

THIRD STREET IMPROVEMENTS
NE THIRD STREET - NE ADAMS STREET TO NE JOHNSON STREET
MCMINNVILLE, OREGON

File No. 0208183-000
July 2024

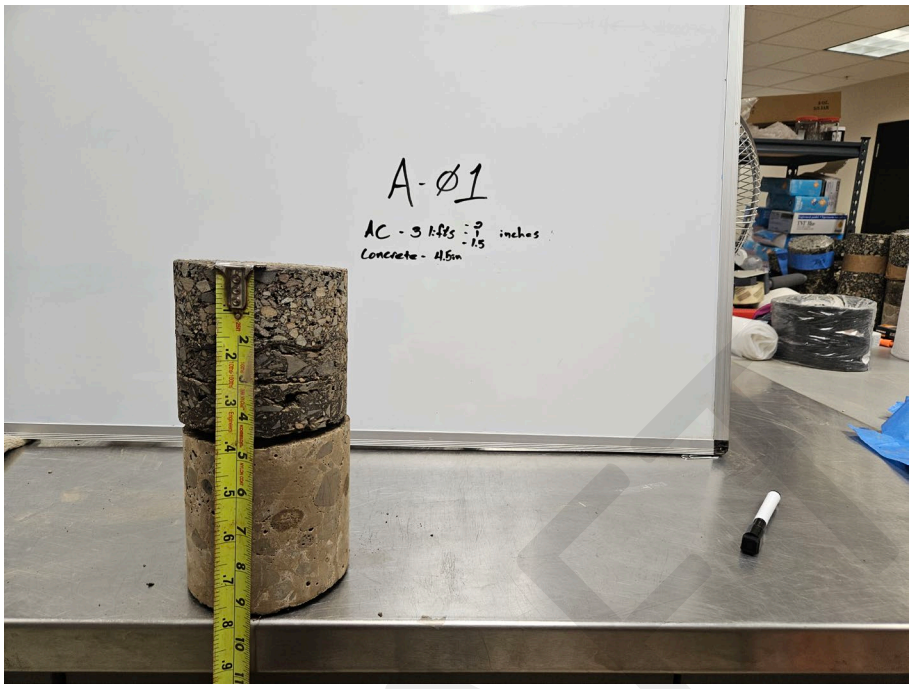
Photo 1: Pavement core from exploration location A-01.

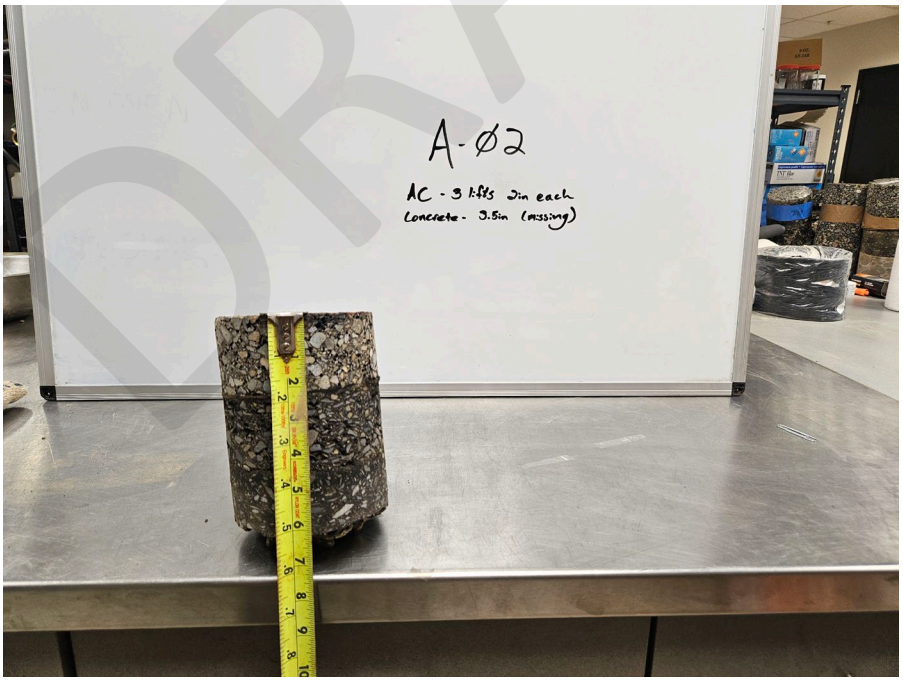
Photo 2: Pavement core from exploration location A-02.

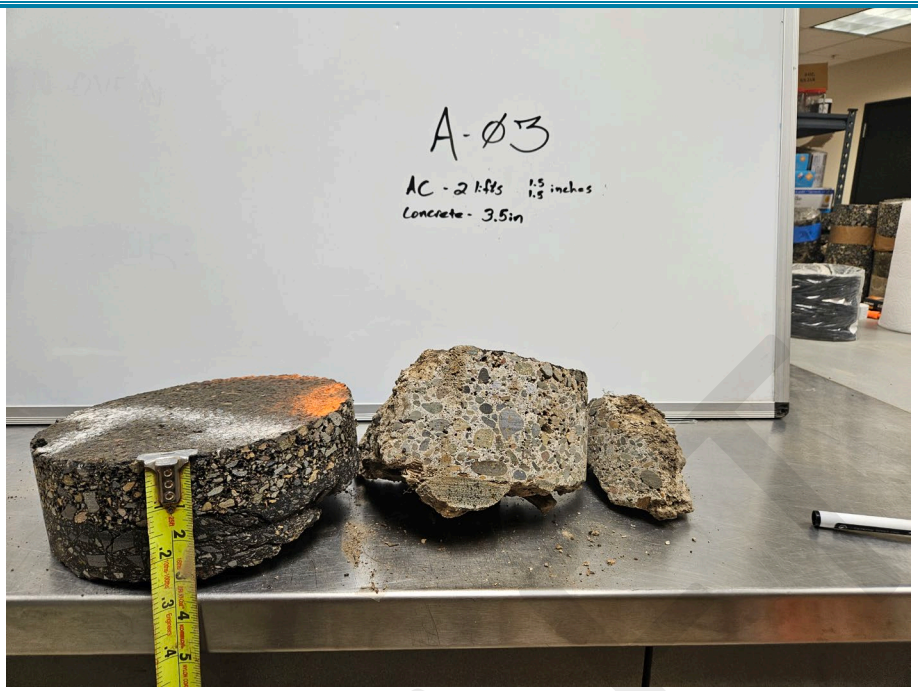
Photo 3: Pavement core from exploration location A-03.

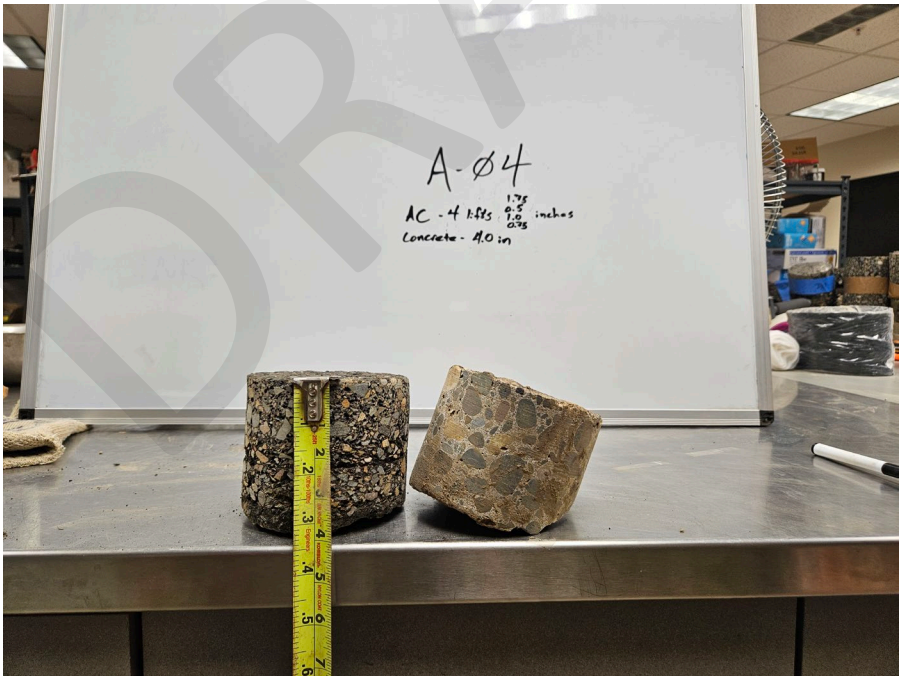
Photo 4: Pavement core from exploration location A-04.

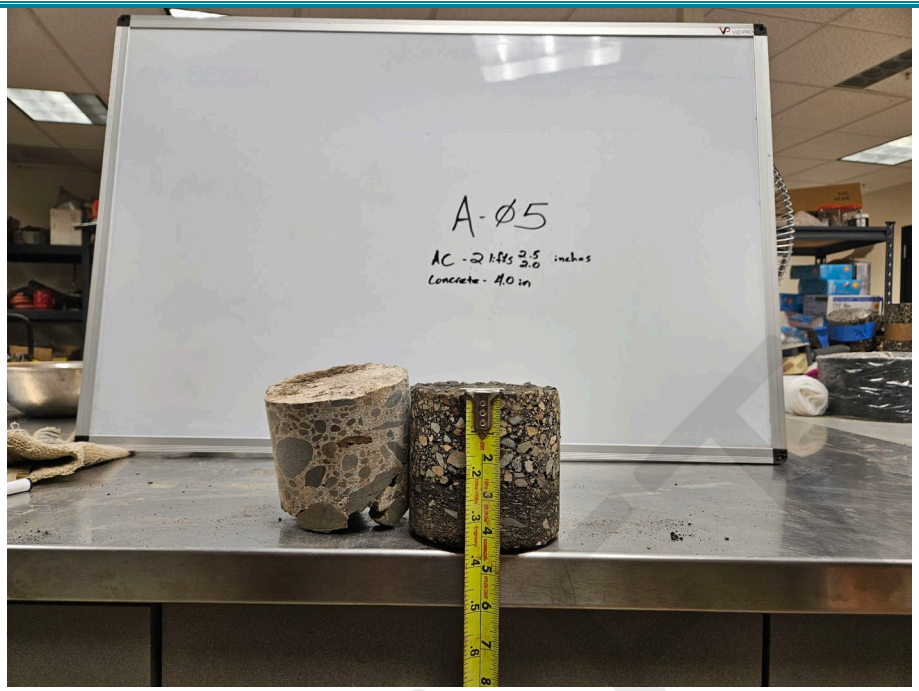
Photo 5: Pavement core from exploration location A-05.

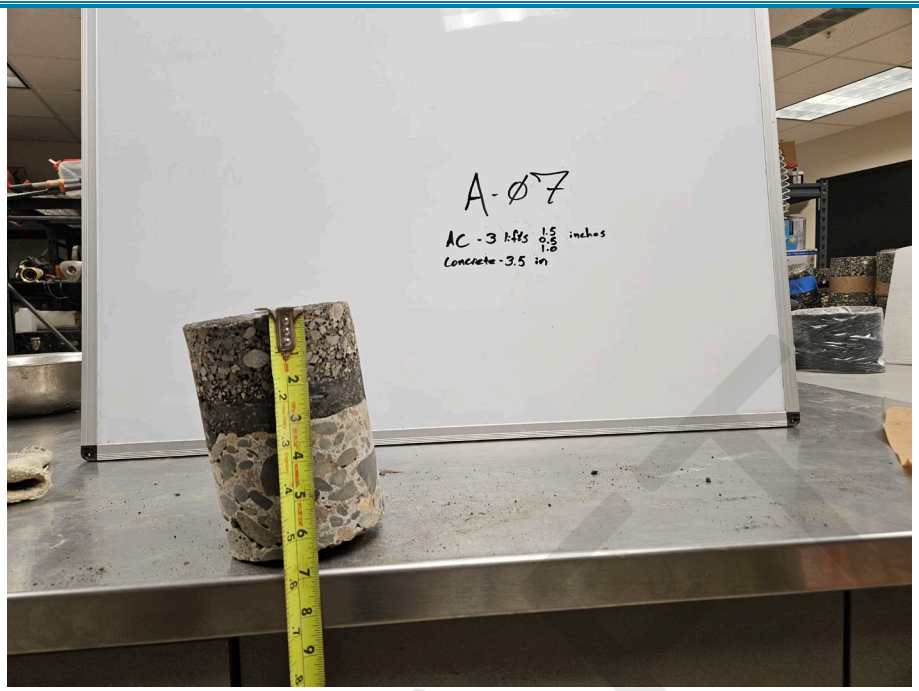
Photo 7: Pavement core from exploration location A-07.

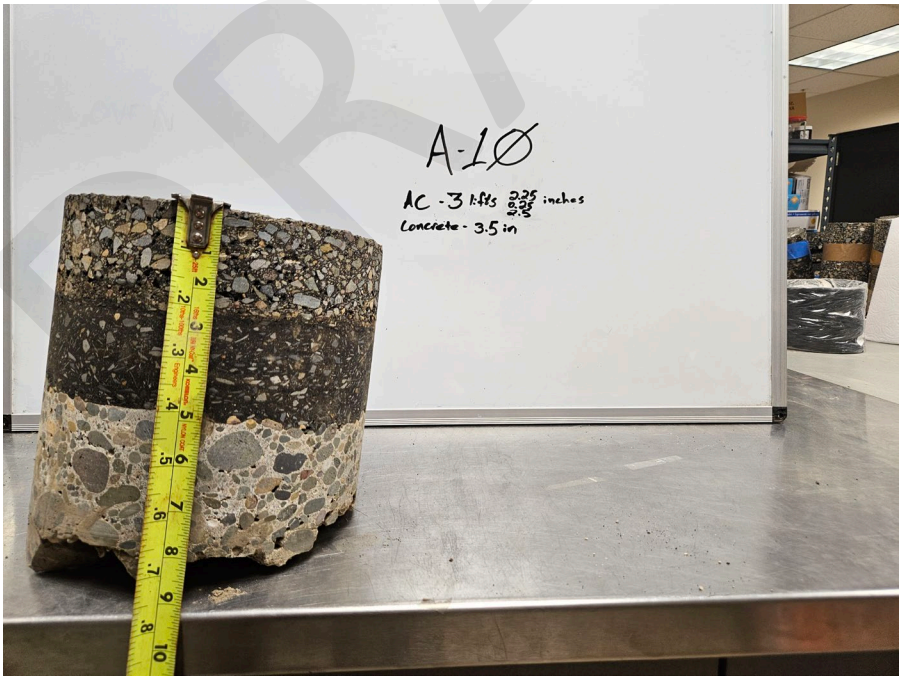
Photo 10: Pavement core from exploration location A-10.

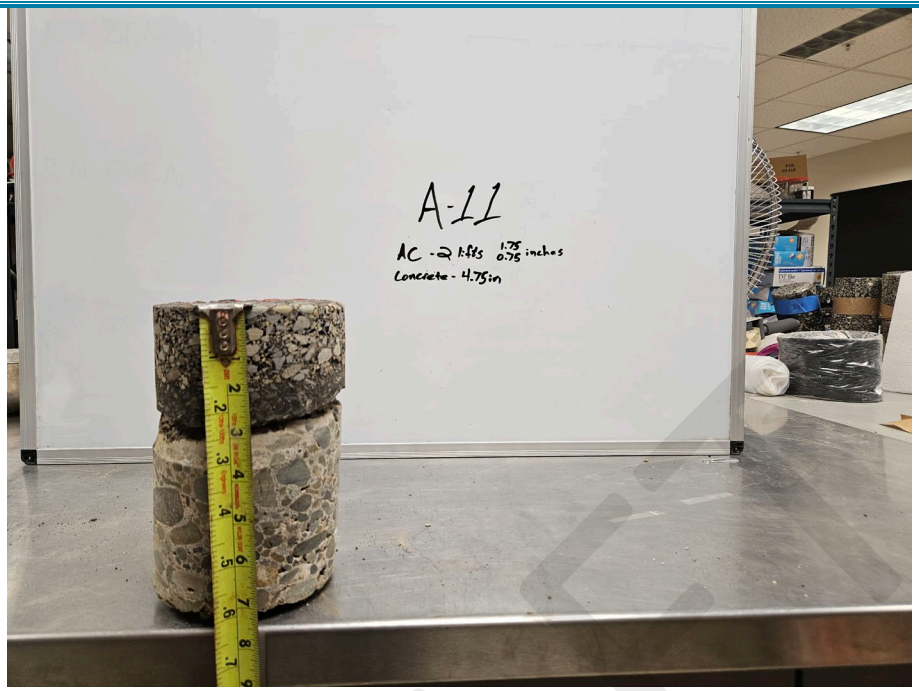
Photo 11: Pavement core from exploration location A-11.

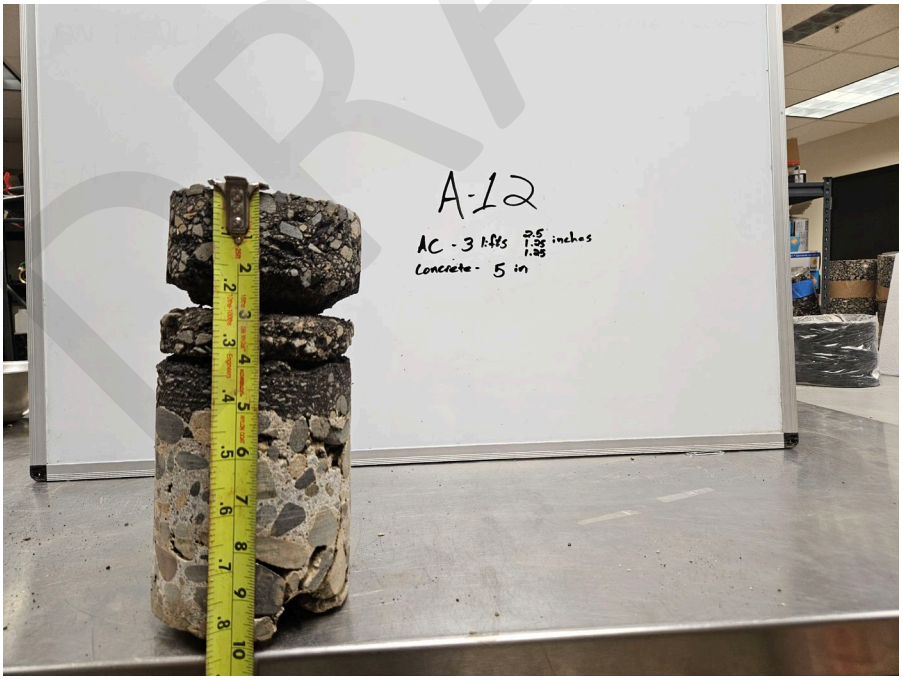
Photo 12: Pavement core from exploration location A-12.

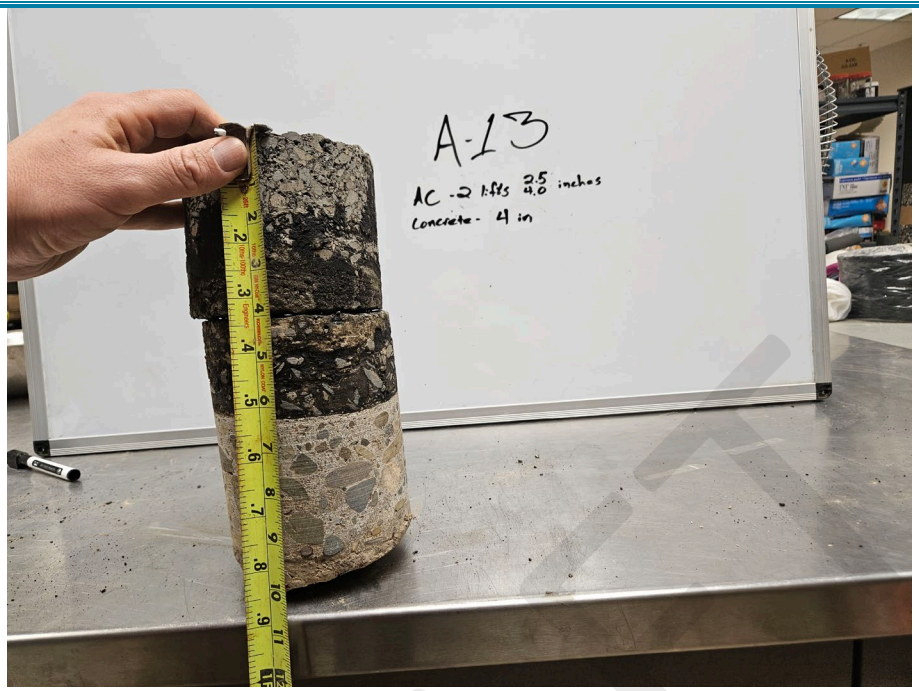
Photo 13: Pavement core from exploration location A-13.

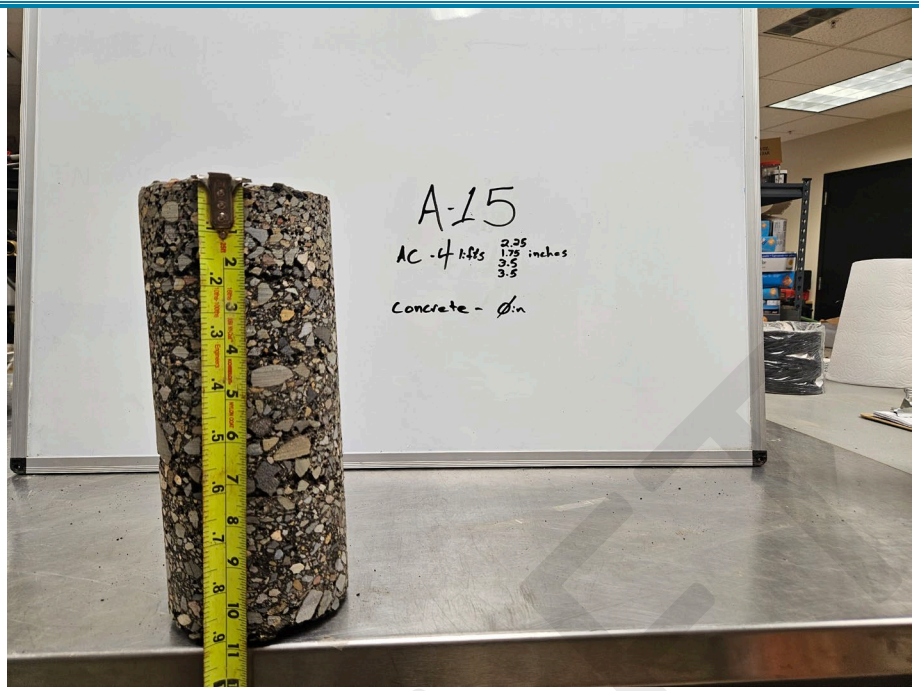
Photo 15: Pavement core from exploration location A-15.
